SERVICE REPORT

Service: Basic Aerial Inspection

SAMPLE REPORT

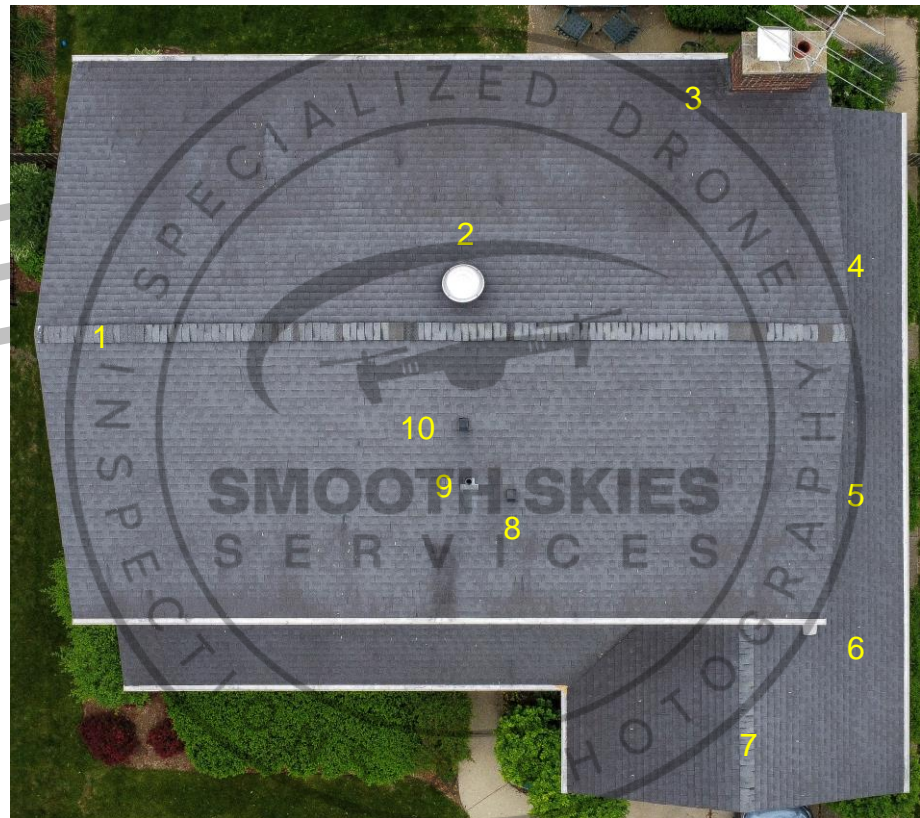
BIRDSEYE VIEW

- Two story home with 8 obstructions and 2 ridge vents
- Plumbing vent - 9
- Ridge vents – 1, 7
- Chimney - 3
- Box vents (1st floor) – 4, 5 & 6 (*)
 - Static exhaust vent with no dampers
- Box vents (2nd floor) – 8 & 10
 - Static exhaust vent with dampers
- Roof top attic fan – 2

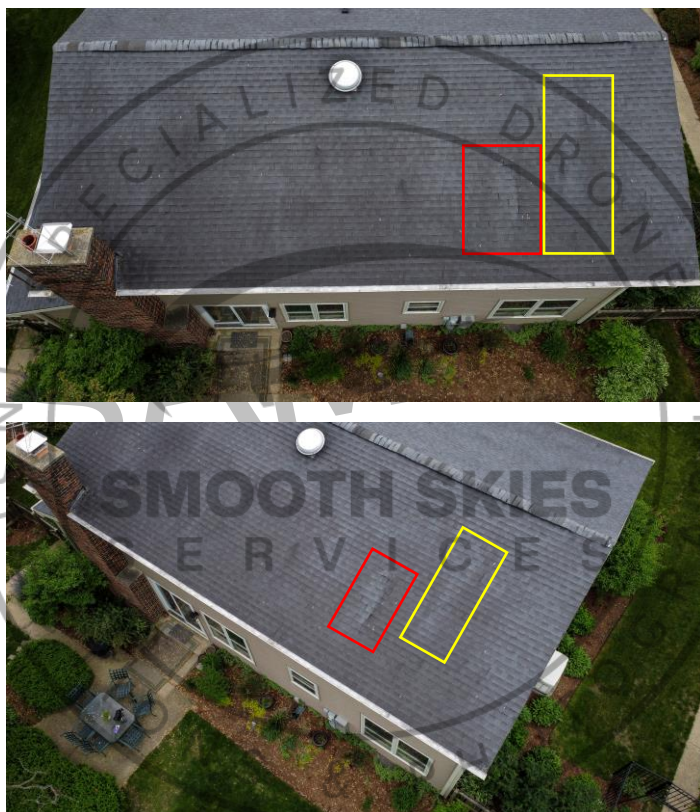
West and Southwest Aerial Views

- Ridge vent shingles are worn out; hardly any granules are present.
- The red highlight shows a large bulge on the roof. Roof underlayment and/or deck damage. The roof should be inspected from the attic to determine the extent of the damage.
- The yellow highlight shows the early stages of potential bulge. The roof should be inspected from the attic to determine the cause of the bulging.
- Depending on the extent of the bulging damage, repair/replace the underlayment and/or deck section.
- Typical causes of bulging damage are moisture accumulation.
- Moisture accumulation can originate from damaged insulation and/or poor ventilation.

- Two visible bulges are located on the second-story east roof. These should be inspected by a qualified roof builder immediately. The inspection should be performed from the top of the roof by removing the shingles and from the interior thru the attic to determine the cause and extent of the damage. Bulges typically occur when moisture is accumulating on the underlayment and/or roof decking. Not addressing this urgently can create additional or larger bulges on the roof.

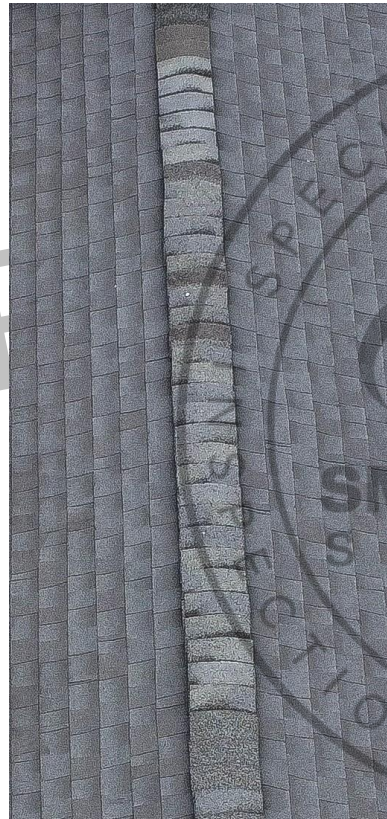
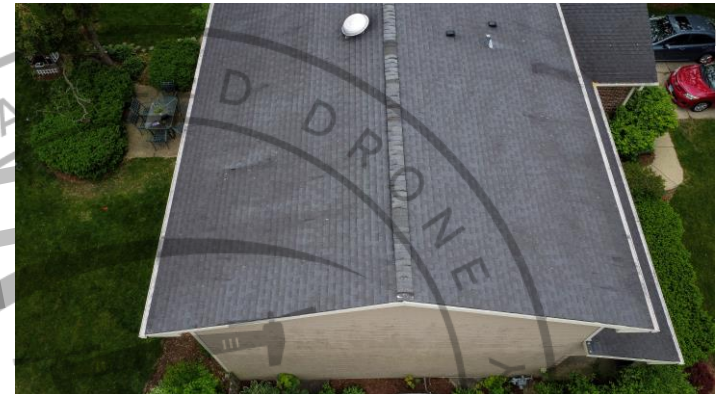
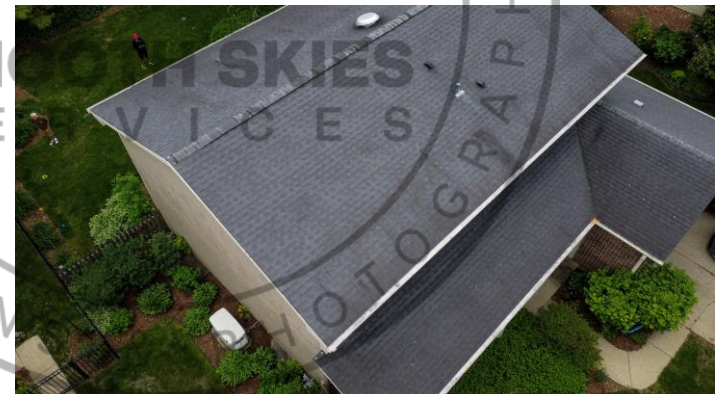
South and Southeast Aerial Views

- No bulging on the second-story west roof.
- Shingles on ridge vent clearly show worn stage
- Ridge vent shingles are misaligned; there are not in a straight line. These are the initial stages of movement and/or detachment.

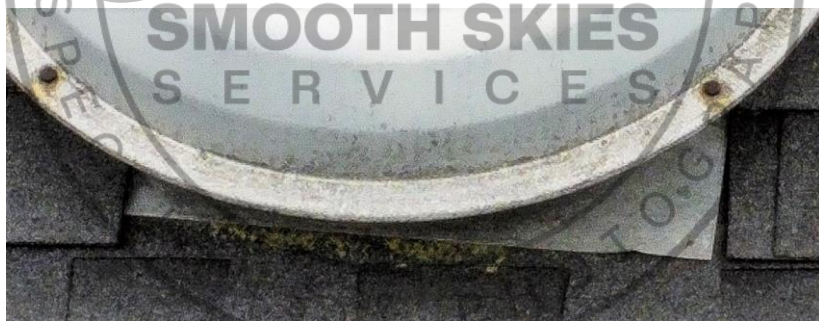
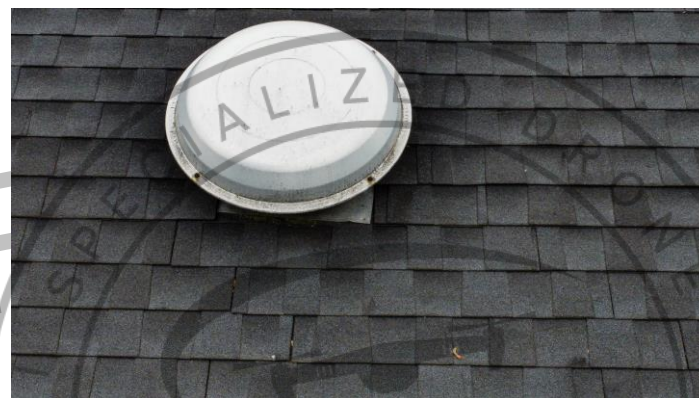
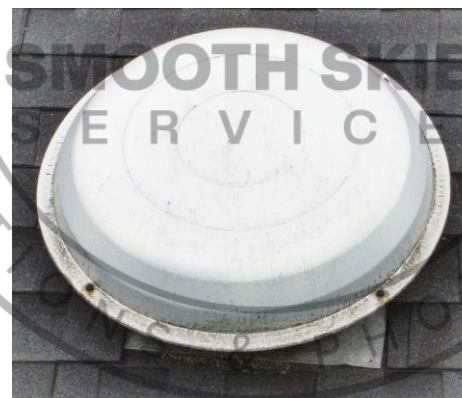
Second Story East Roof Vent (#2)

- Attic fan shows signs of movement. The lower right corner is misaligned with the shingles.
- Screws on the perimeter have rust.
- Ensure the fan is operating as intended to ensure proper attic ventilation and management of moisture removal.

- Confirm that the second story, east roof, attic fan is working properly so that it moves the hot air, and moisture, out of the attic. Replace all rust bolts/screws from the fan. Additionally, have the fan repositioned so it is lined up with the roof shingles since it is not aligned.

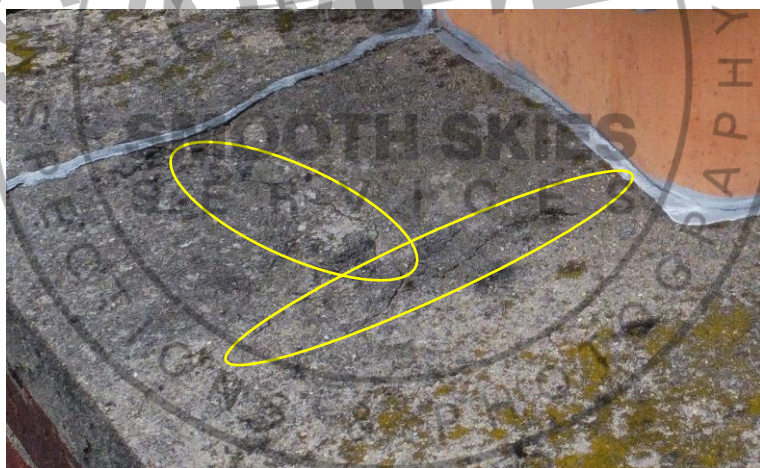
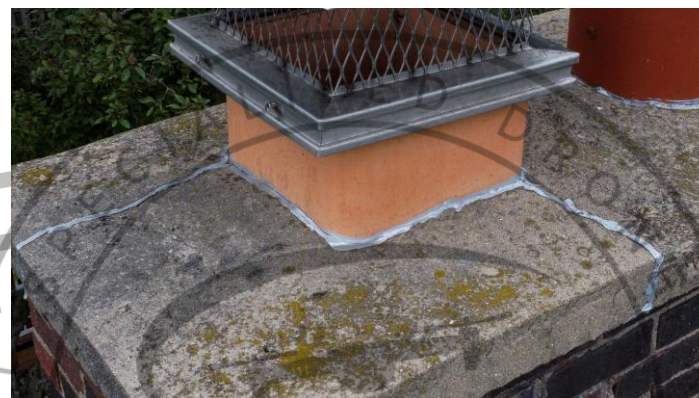
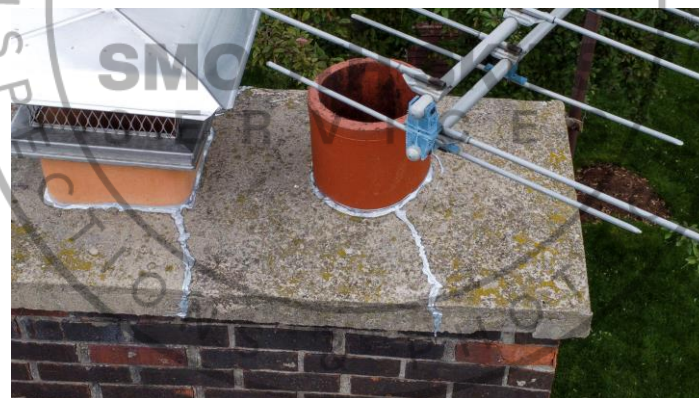
Southwest Corner Chimney

- There are two small cracks in the chimney. These are highlighted in yellow.
- Consider adding a metal grille to the right circular vent on the chimney to prevent debris and/or wildlife penetration.

- Get chimney cracks sealed on the northern side of the chimney.
- Repair/replace the pushed-up shingles west of the chimney on the 2nd story east roof. Add a metal grid cap to the southern vent on the chimney to prevent a means for debris or wildlife to enter.

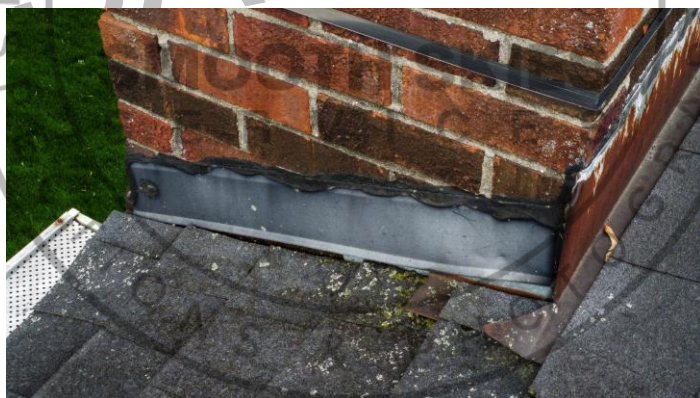
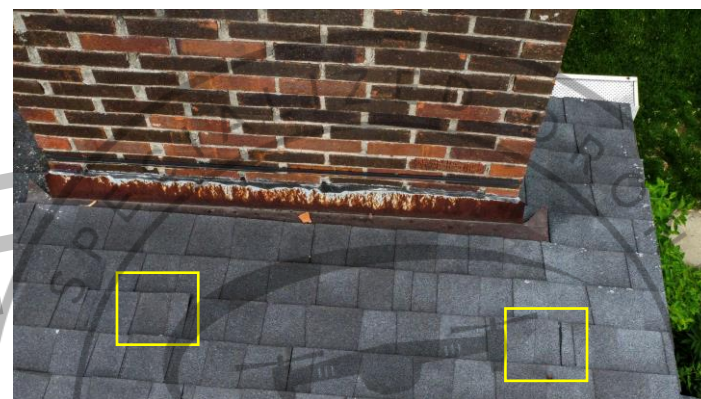
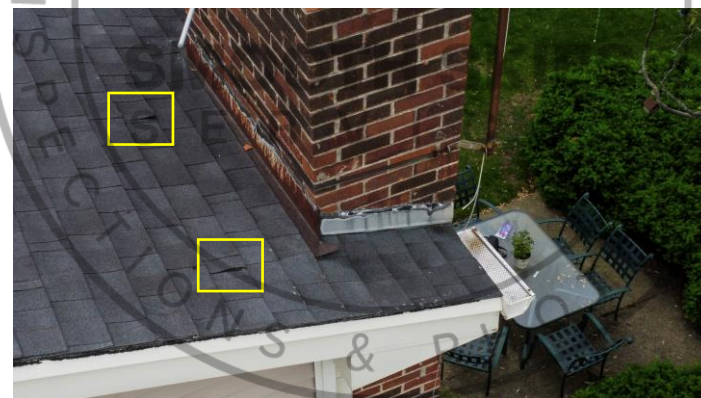
Southwest Corner Chimney

- Chimney flashing shows prior repairs to prevent leaks from walls onto the roof.
- While flashing has signs of rust the lower flashing/diverter looks in good condition.
- There are a couple of single shingles that are being lifted, probably nail pop-ups. These need to be repaired.

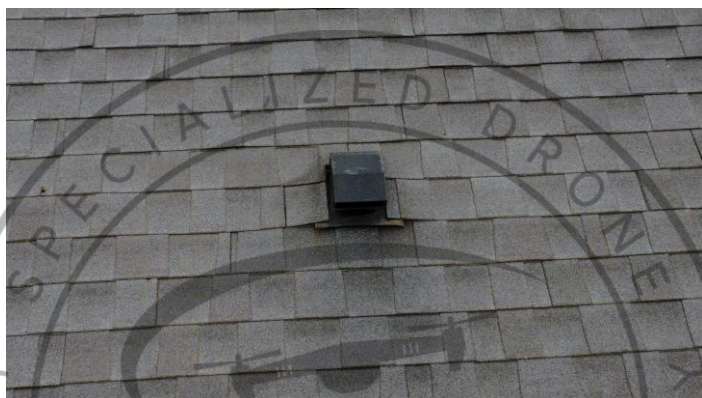
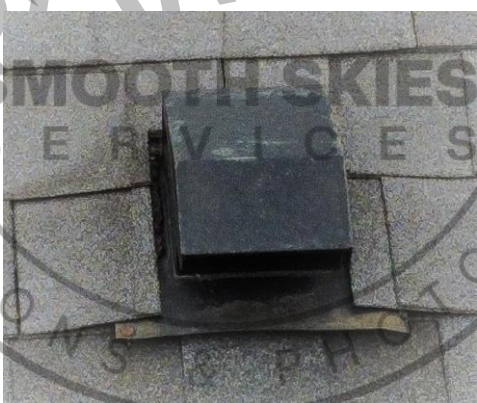
Second Story West Roof Vent (#10)

- Vent is damaged and has been significantly raised from the roof.
- Replace vent.
- Inspect the attic at this location for possible underlayment and/or decking damage.
- Inspect surrounding shingles for any additional damage.
- Additionally, identify the source of the rust on the vent nails.

- Add a metal grid cap to the plumbing vent on the second-story west roof to prevent debris or wildlife to enter.
- Replace static box vent on 2nd story west roof.

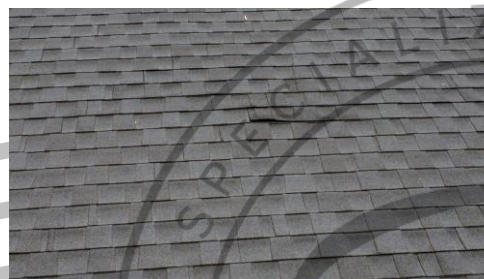
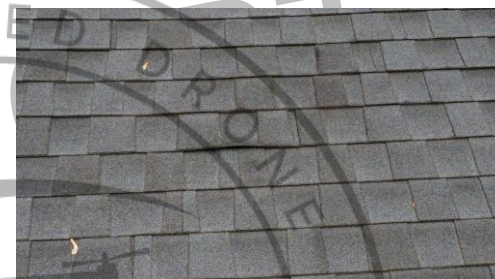
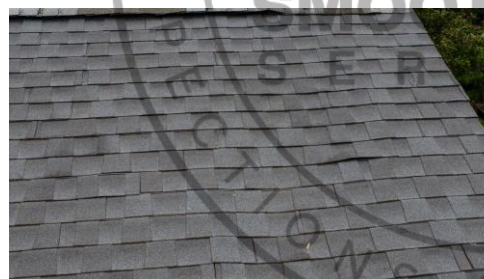
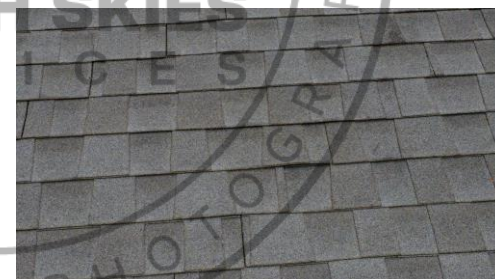
2nd Story Roof East View Close Ups

- There are four areas on the roof where shingles are starting to be pushed up.
- Possible cause is nail pop-ups.
- Have these four areas closely examined by a roof contractor and repair as required.
- Since these four areas are “single shingle” events, most likely there is no underlayment and/or decking damage. Confirm this by inspecting the attic for these locations.

- Repair the four pushed shingles on the 2nd story east roof
- Replace two(damaged) of the three boxed vents on the 1st story south roof
- Repair the pushed shingle on the 1st story west roof.

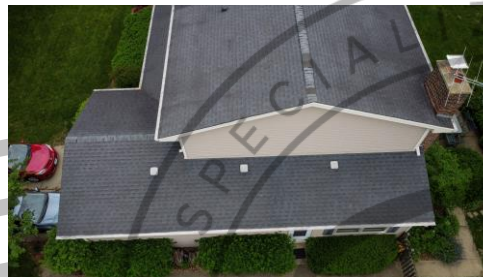
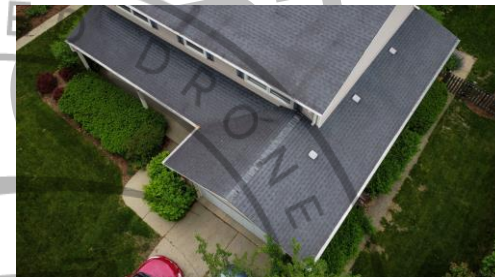
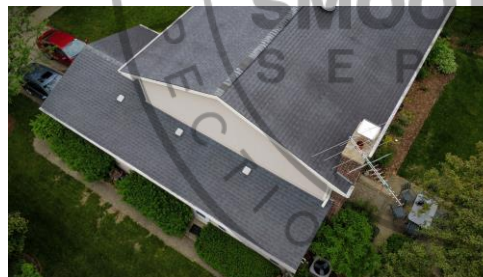
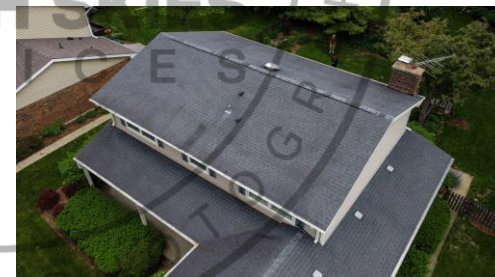
1st story Roof Aerial Views

- From these views we can see both stories' ridge vents shingles are significantly worn.
- These shingles need to be replaced.
- The 1st story ridge vent shingles are not showing any sign of movement, unlike the 2nd story ones.

- Get the underlayment and roof deck inspected for both floors inspected by a qualified roof builder; especially on the 2nd story east roof.
- Have both 1st and 2nd story ridge vents closely inspected, including from the attic. Additionally, replace all shingles from the ridge vents because they are worn out.

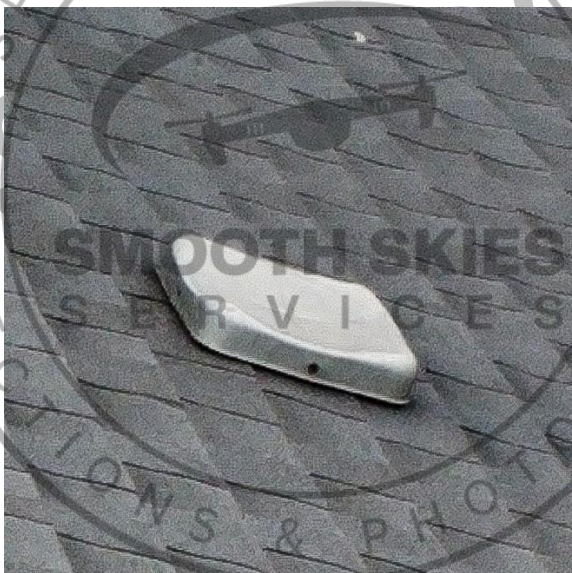
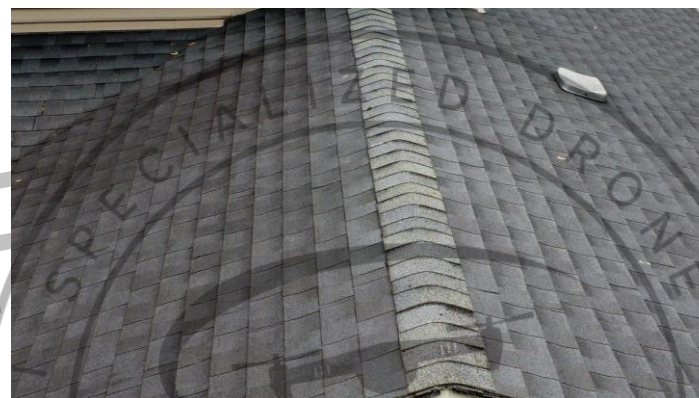
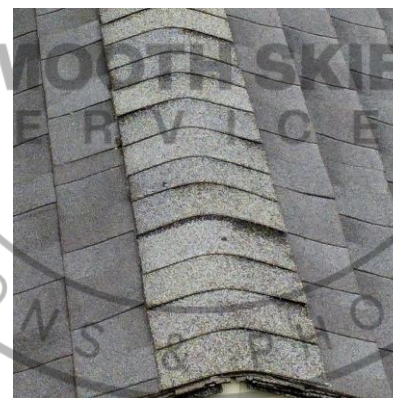
1st Story Roof Ridge Vent (#7)

- Ridge vent shingles need to be replaced, they are worn and have very little if any, granules left.
- Western box vent (#6) shows damage. It should be replaced.

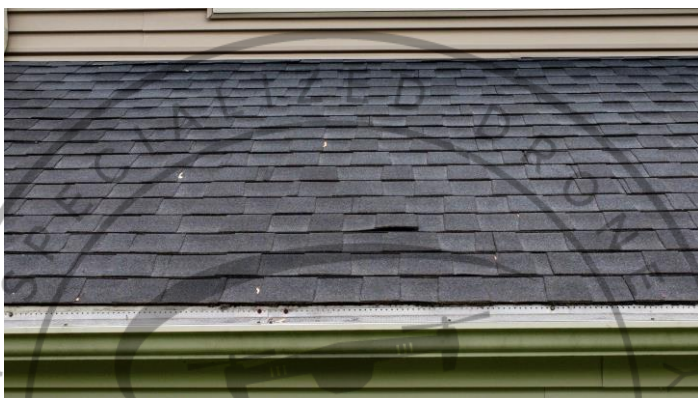
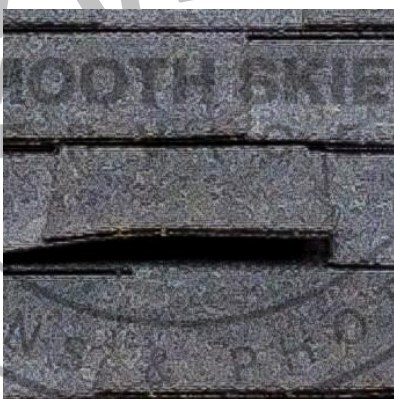
1st Story Roof East View Close Up

- A single shingle on the middle of this roof section is popping up. Possible nail pop-up.
- This should be repaired.
- Additionally, inspecting the attic, if possible, for any potential attic damage below this shingle.

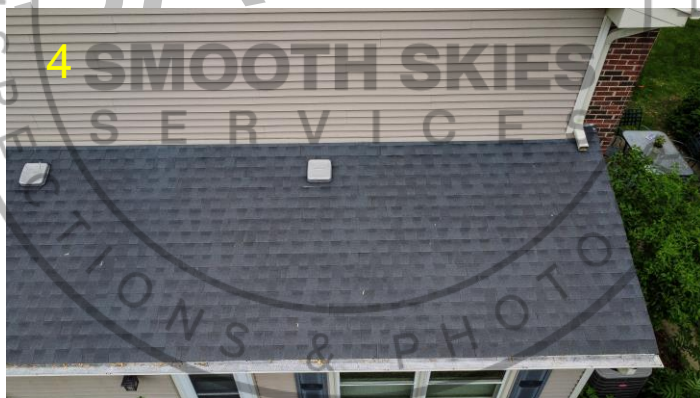
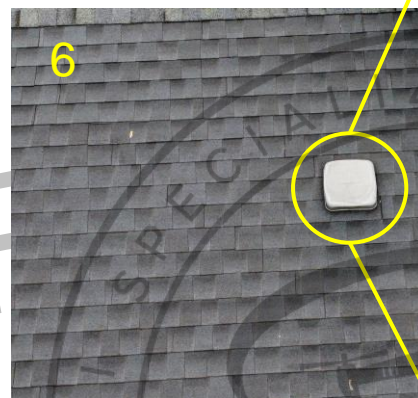
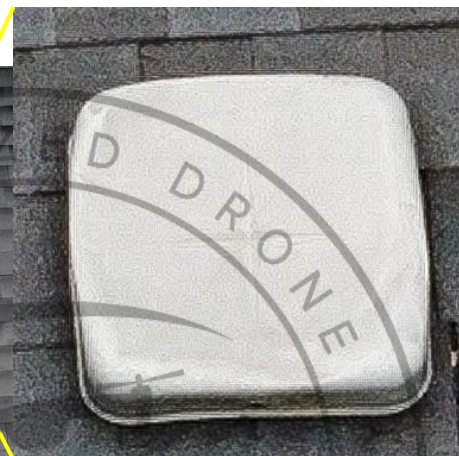
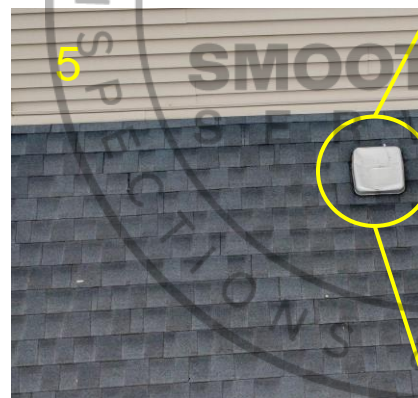
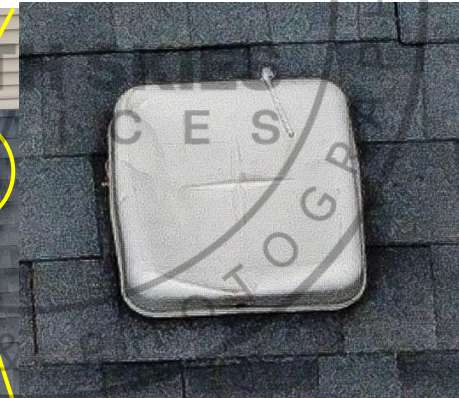
1st Floor Boxed Vents

- Vents #5 and #6 are damaged.
- They should be replaced.
