SERVICE REPORT

Service: Basic Aerial Inspection

SAMPLE REPORT

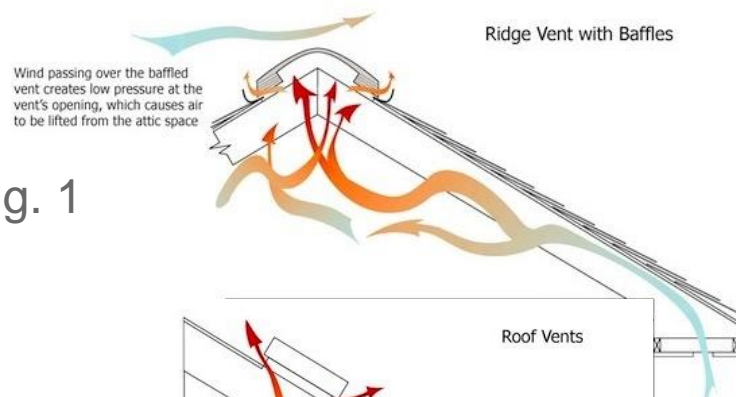
Fig. 1

- Roof vents should be installed near the roof peak. Figure 2 shows cool air entering the soffit vents.
- One of the most efficient ventilation methods is the continuous soffit vent combined with the continuous ridge vent (Fig. 1).
